Model Year 2020 Zero SR/F Firmware Update Service Campaign

Firmware Release Notes (Build 246 / Revision 9)

1 SV-ZMC-020-405

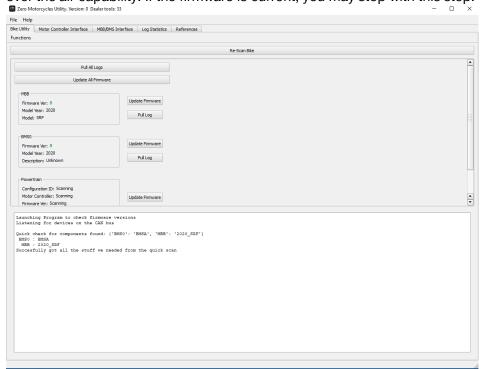
6. Make sure that the ZDU identifies the correct motorcycle model year and model. Note that the picture below shows firmware versions 8, but the new versions for the 2020 Zero SR/F are 9 for both the MBB and BMS. In many instances, owners will have already updated their motorcycles to the latest firmware using the over-the-air capability. If the firmware is current, you may stop with this step.

- 7. Click the "Update All Firmware" button. When asked, click on the "Yes" button to pull logs prior to the firmware update because this process erases the existing logs. The log files are saved to your local computer in the location C:_Zero\Bike_Logs
